**PÖIDE
2003**

Workshop on plaster conservation

22-27 April 2003, St. Mary's church of Pöide, Estonia

Report

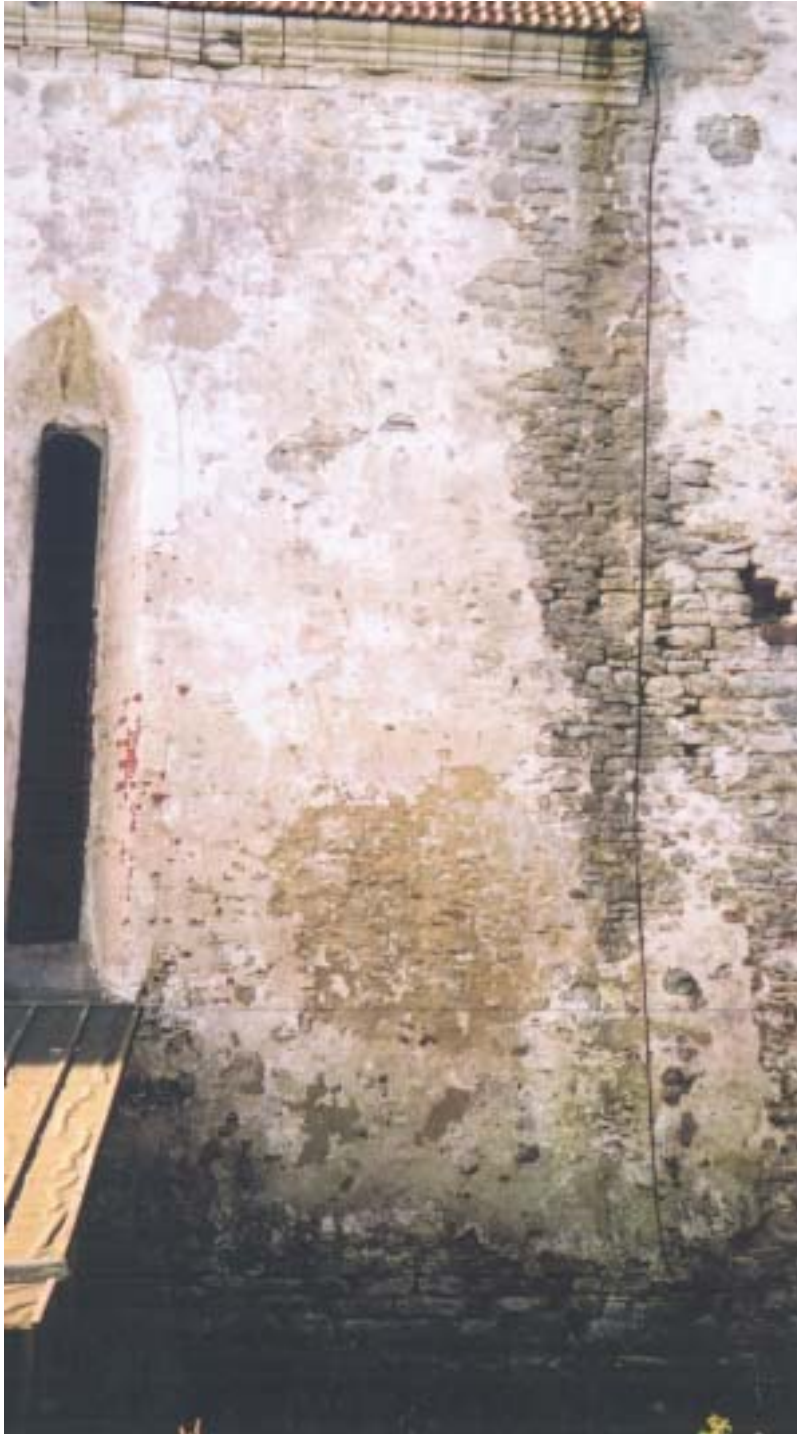
**The research area
on the northern
façade**

The research area was located on the northern façade at the joint section of the nave and the tower.

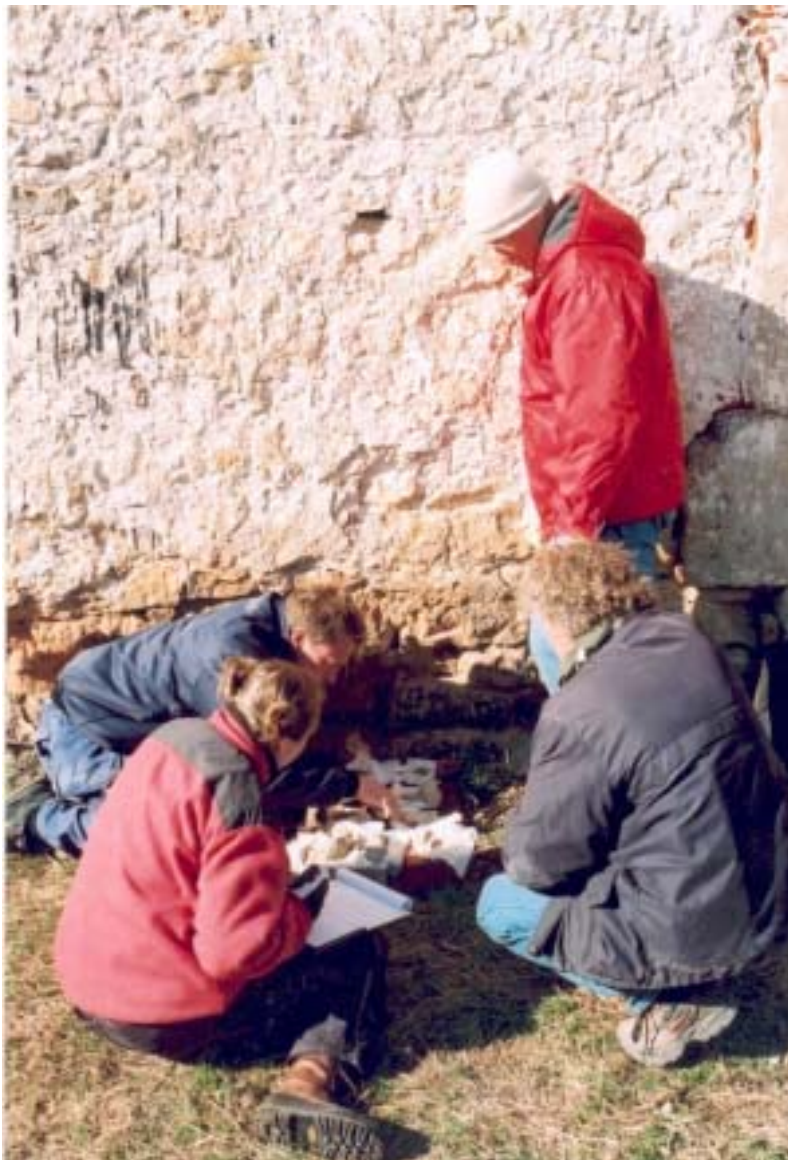
**Acid testing of
plaster samples**

Working groups which worked with the analysing and mapping of the conditions of historical plasters and with acid-tests, also worked on the recipe for infill conservation mortar which can be used for the conservation of the façades of Pöide church.

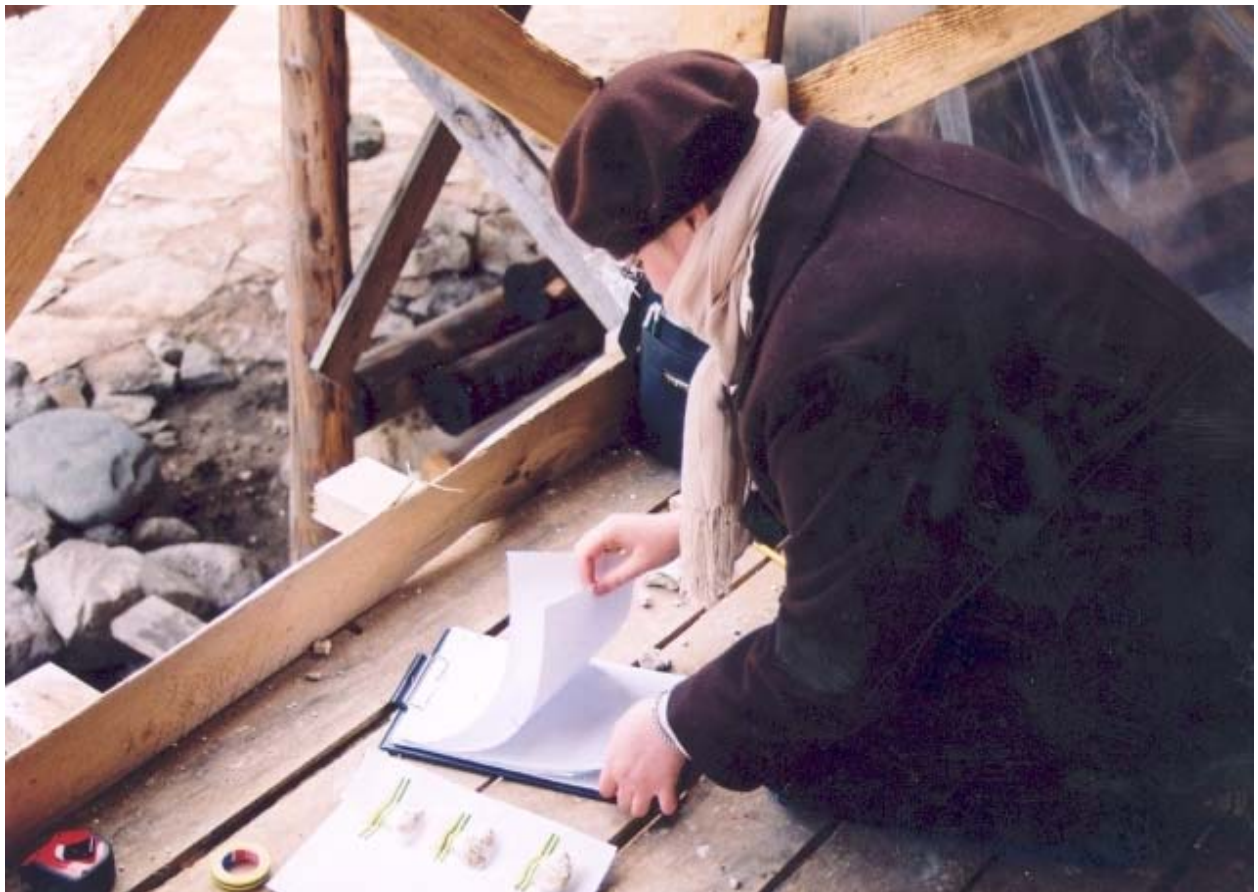
Recording plaster samples
